TECHNICAL FIRST FUELIE GOES GREEN

First Fuelie Goes Green

PUTTING #10 BACK TO ITS ORIGINAL SHADE OF CASCADE

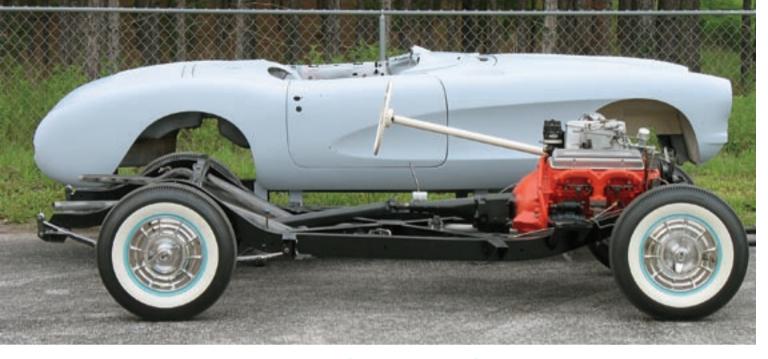
1 One of the best ways to remove layers of paint is with a stripper agent. Once we got down through several layers of different colored paint, the original Cascade Green began to show through. We could also see the original grease pencil marks from when the body was originally constructed.

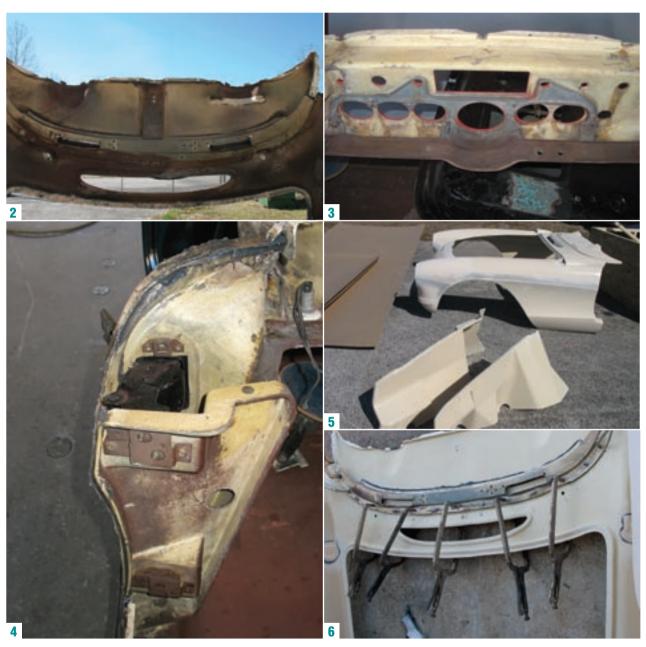
2 Our Corvette Image front end already has the upper dash panel attached, but we needed to remove the metal bracing under the dash panel to attach it to the new body panels before mounting.

3 This is a view that not many enthusiasts get to see — the backside of their dash panel from the top. Notice that all of the bonding areas have been sanded in preparation for a solid bond to the new pieces. If there are any

4 Likewise, this is a front view of the passenger-side door hinge. Again, all of the bonding areas need to be cleaned, and the new panels installed and checked for fit before any bonding agent is applied. Taking this necessary step ensures that all of the bonding strips are solid and that the body will be as strong as the factory designed it.

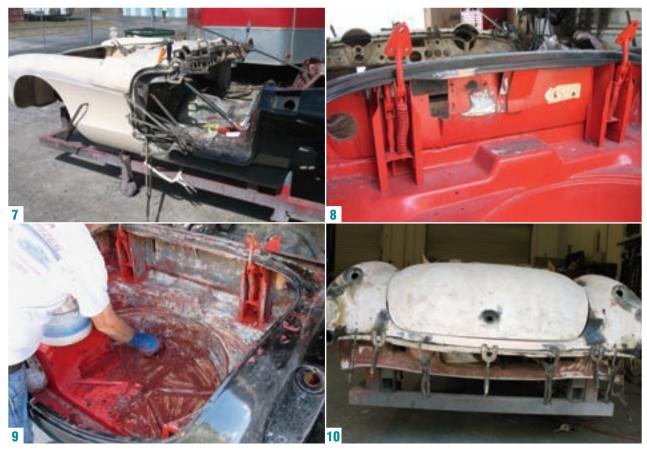
7 Getting the front end to fit the body isn't nearly as hard as keeping it there until the boding agent has a chance to cure. Screwdrivers align various holes, while the army of Vice-Grips keep the panels in place until the bonding strips can cure properly.

8 This car originally had RPO-419, (Auxiliary hardtop) as well as RPO 473 (Power-operated folding top) as

evidenced by the holes in the rear panel. This car was to be the media test vehicle for the new fuel-injection system. Since a power top didn't help performance, it was removed when the engine and fuel system were swapped out by Chevrolet Engineering. We are restoring this car to that configuration, with its originally installed fuel-injection system, so the power system will not be installed.

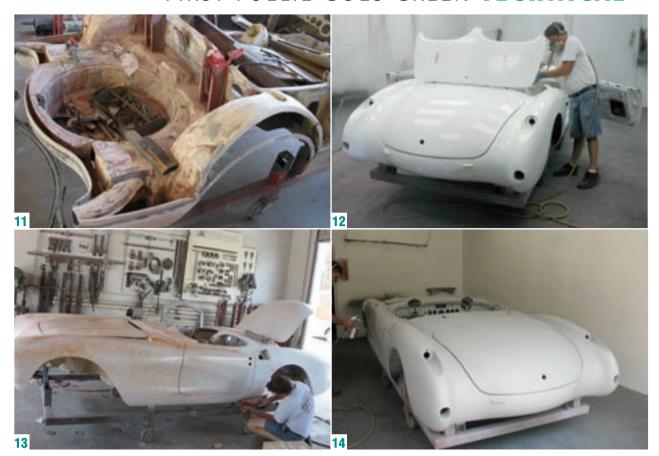
11 That meant removing the entire upper surround. Note again that all the bonding strips have been dressed and prepared to ensure a strong, proper bond to the new panels.

12 After all the body panels were fitted properly, it was time to gelcoat the entire body. The Corvette Image pieces required using a special gelcoat by Evercoat to keep the warranty on

13 After the gelcoat has had time to cure, John at J&M sprayed a light coat of contrasting color on the body as a guide coat. The idea is to block-sand the entire body, allowing the guide coat to show any low areas that will need to be corrected before priming. This ensures a nice,
